Flood Mitigation and River Pamba in Kerala– Insights and Measures with Special Reference to Thottappally

Venugopal, C.K

Kerala Institute of Tourism and Travel Studies (KITTS),

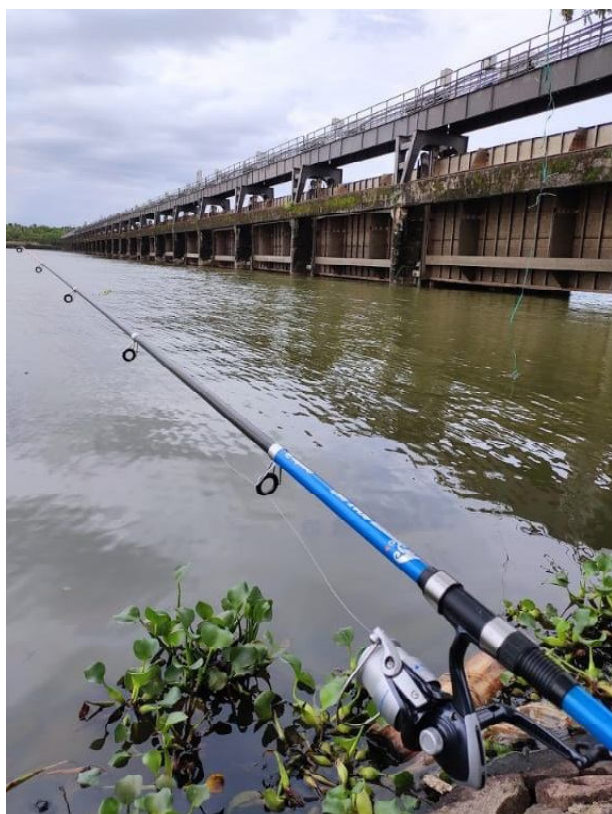
Fig. 1. Thottappally Spillway, Kerala

The Thottappally spillway shown in Fig. 1 was constructed in 1955, as part of Kuttanad development scheme for relieving flood condition in Kuttanad, by diverting flood waters of Pamba, Manimala, Achenkovil and Meenachil directly to the sea. Though the original discharge capacity of the spillway was about 1812 cumec, it is reported that at present the average maximum discharge passing through the spillway is limited to 630 cumec, which is almost 1/3rd of the design capacity of the spillway (SRF Report, 2007).

The maximum monthly dispatch of floods entering the Kuttanad region during the monsoon months was estimated as 69000 cusecs, and the spillway was designed to discharge more than 90 percent of it directly to the sea. However, while designing the spillway the problem of piling up of water due to the rising sea level during the

monsoon months and the consequent formation of the sand bar on the seaward side of the spillway was not taken into account. Therefore, after the spillway was completed in 1955, the realized capacity of it is found to be less than one - thirds of the estimated capacity and hence fails to serve its purpose to some extent (Thomas, 2002).
